# ANNUAL REPORT FOR 2014

**Banks School Road Wetland Mitigation Site**  
**Lenoir County**  
**TIP No. R-2719A**  
**COE Action ID: 200511238**  
**DWR: 20050787**

Prepared By:  
Natural Environment Section & Roadside Environmental Unit  
North Carolina Department of Transportation  
December 2014

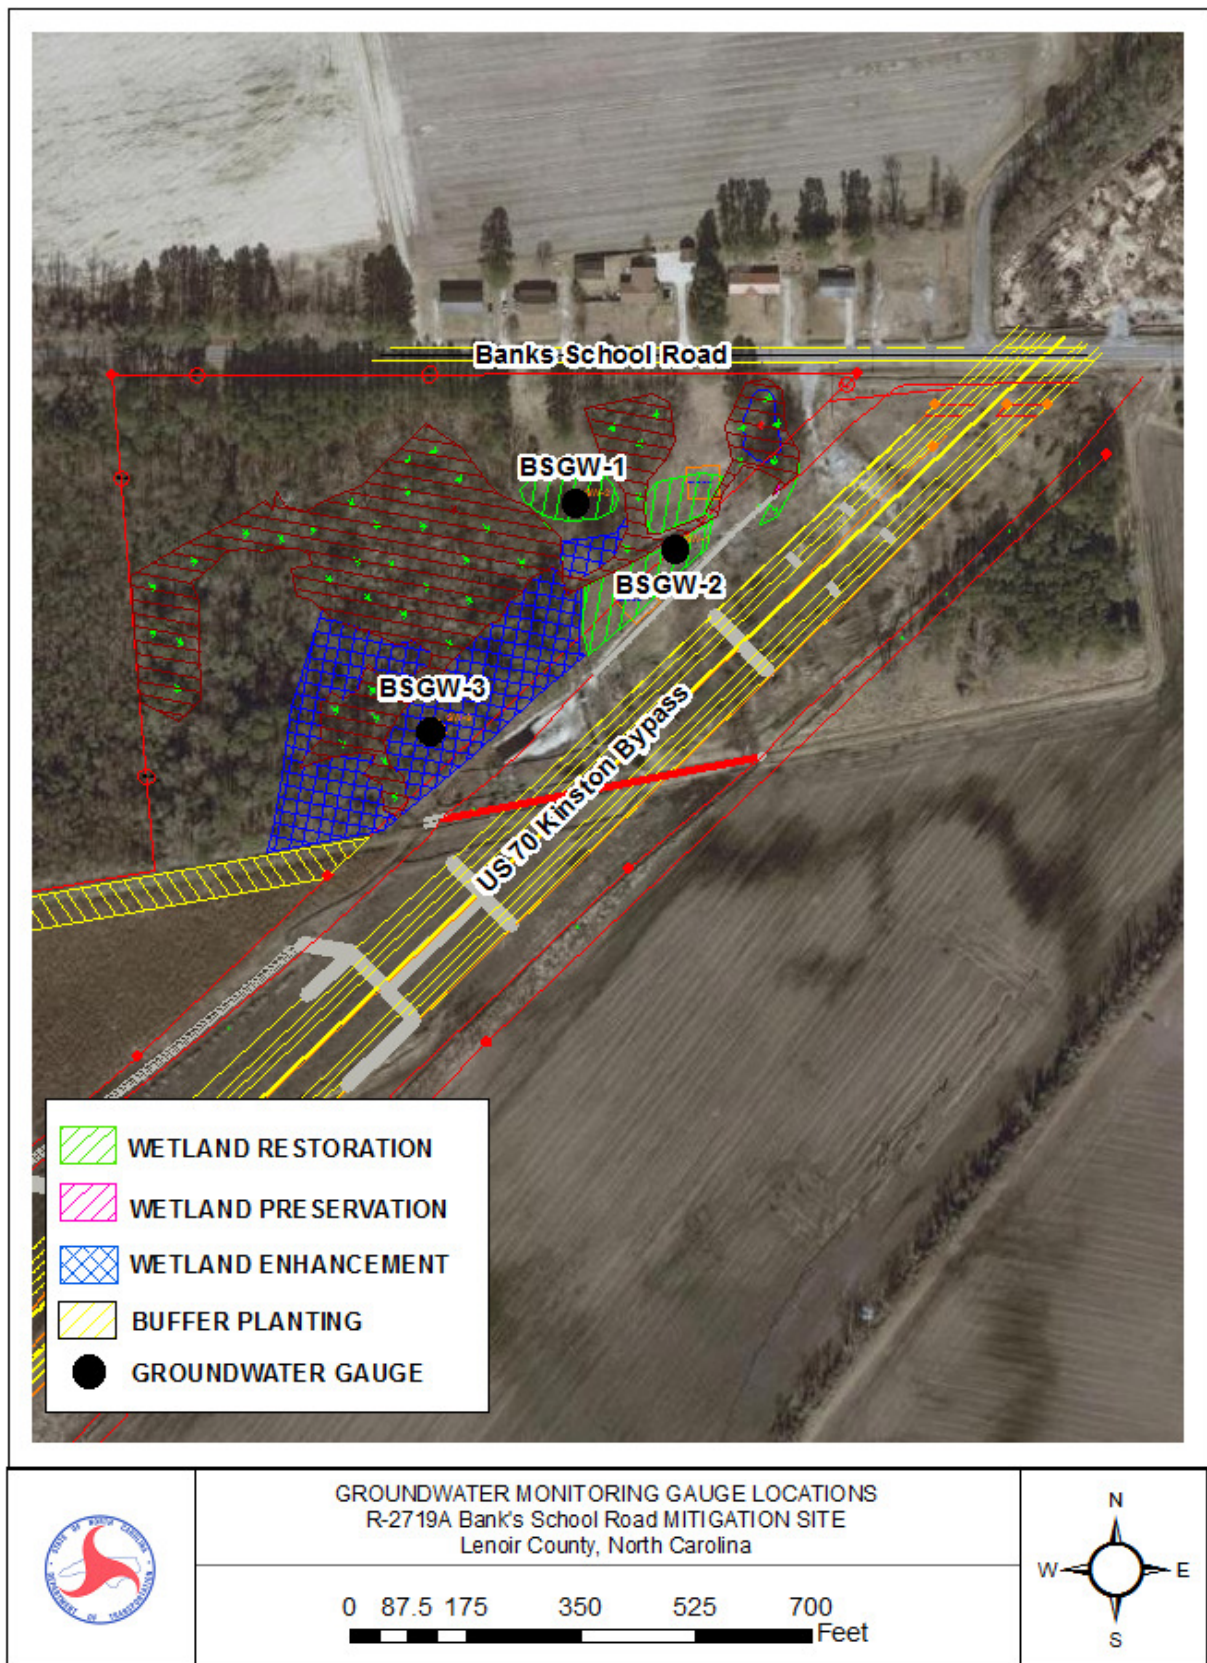
**Figure 2. Monitoring Gauge Location Map**

Three groundwater monitoring gauges are used to record site hydrologic data including two in the restoration area and one gauge in the enhancement area. The groundwater gauges are set to record daily water levels. The hydrologic response (groundwater) to rainfall events is evaluated using data provided by the North Carolina State Climate Office.

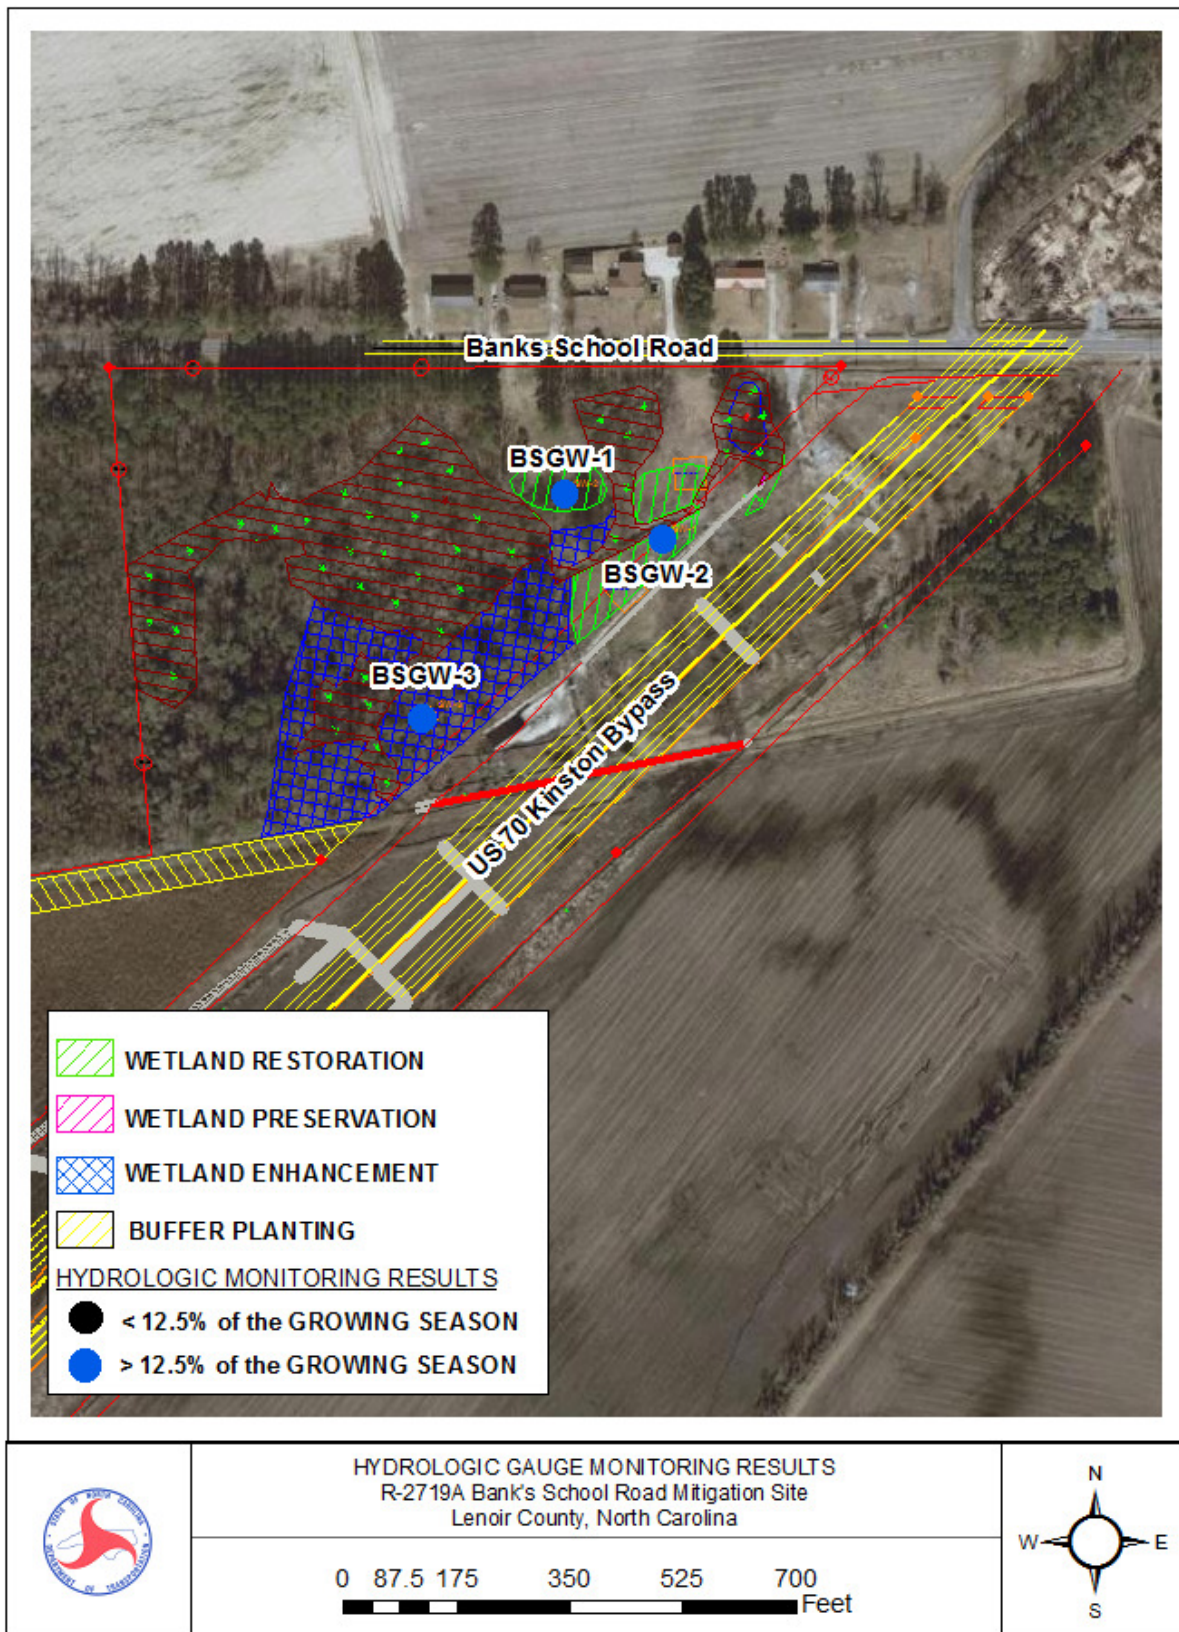
**Figure 3. 2014 Hydrologic Monitoring Results**

The total number of consecutive days that the groundwater was within twelve inches of the surface was determined for each groundwater monitoring gauge. This number was converted into a percentage of the growing season. Table 1 presents the hydrologic results for 2014. Table 2 presents the hydrologic results at the site since construction was completed. Figure 3 is a graphical representation of the hydrologic monitoring results for 2014.

Monitoring Gauge	< 5%	5 – 12.5%	> 12.5%	Actual %	Dates of Success
BSGW-1			X	61.1	Mar 17-June 4; June 20-Nov 15
BSGW-2			X	99.6	March 17-November 15
BSGW-3			X	15.6	March 17-April 23

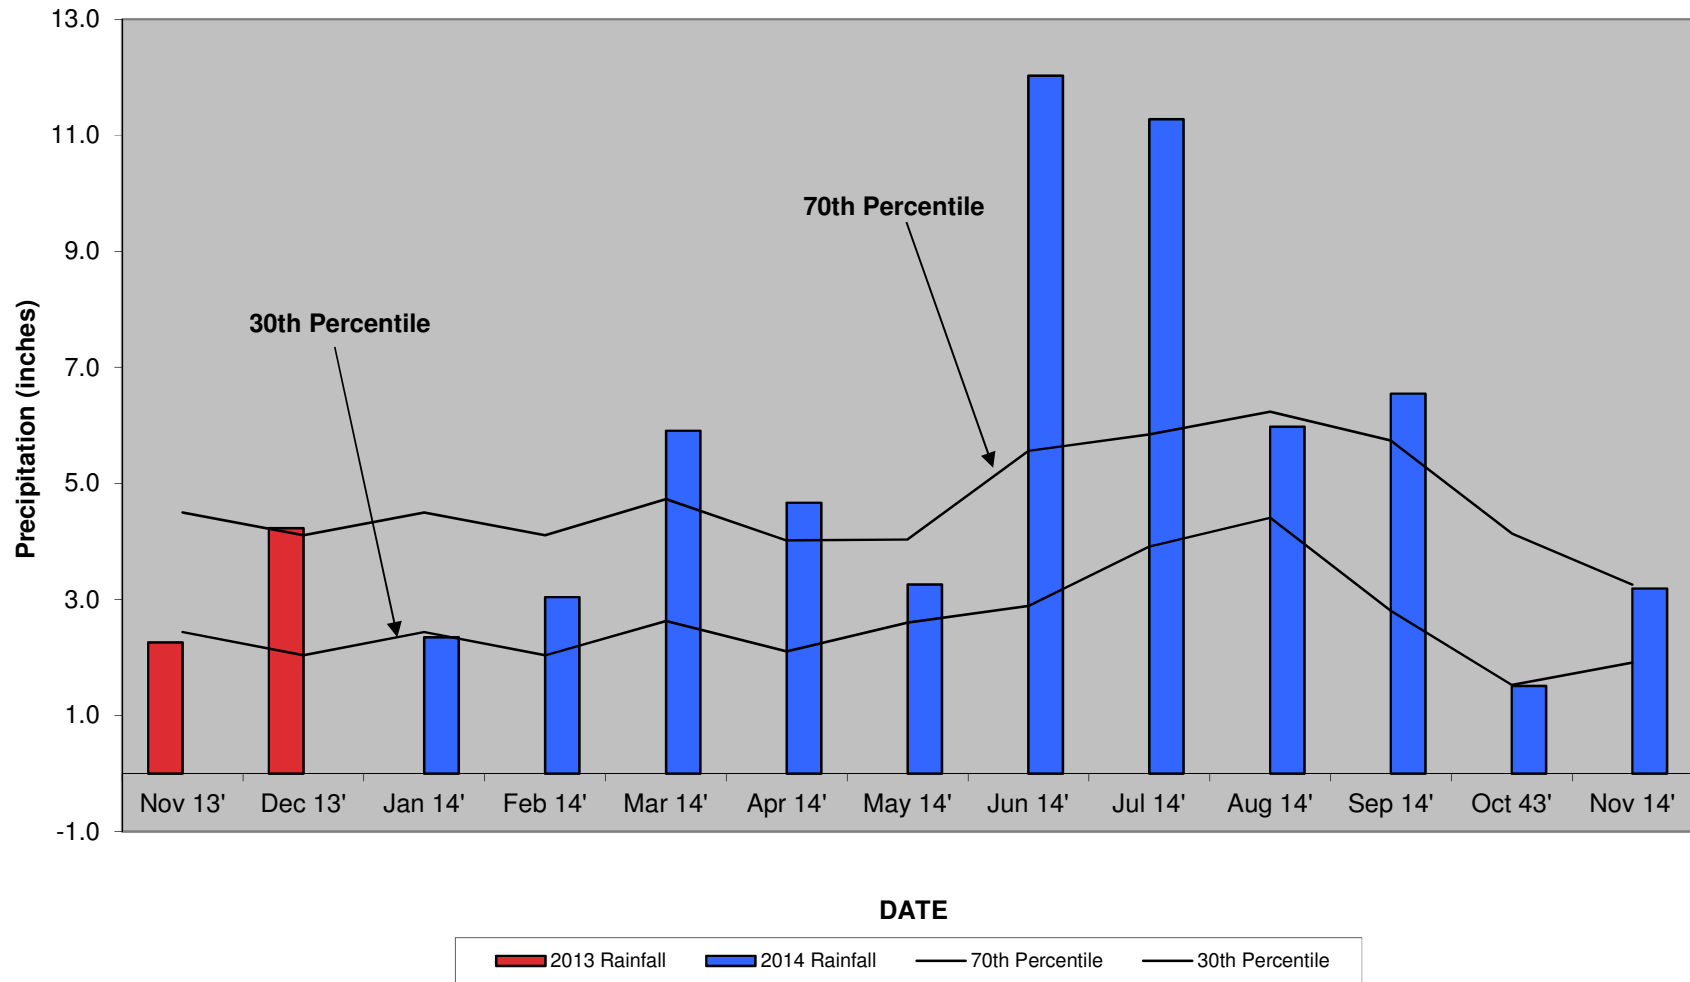
**Figure 4. 30-70 Percentile Graph 2014**

Figure 4 is a comparison of monthly rainfall for the period of January 2014 through November 2014 to historical precipitation (collected between 1984 and 2013) for the Kinston Agriculture Research Station in Lenoir County. This comparison gives an indication of how 2014 relates to historical data in terms of climate conditions. The NC State Climate Office provided all local rainfall information.

For the 2014-year, February, May, August and November experienced average rainfall. January and October recorded below average rainfall while March, April, June, July and September recorded above average rainfall. Overall 2014 experienced an average to above average rainfall year.

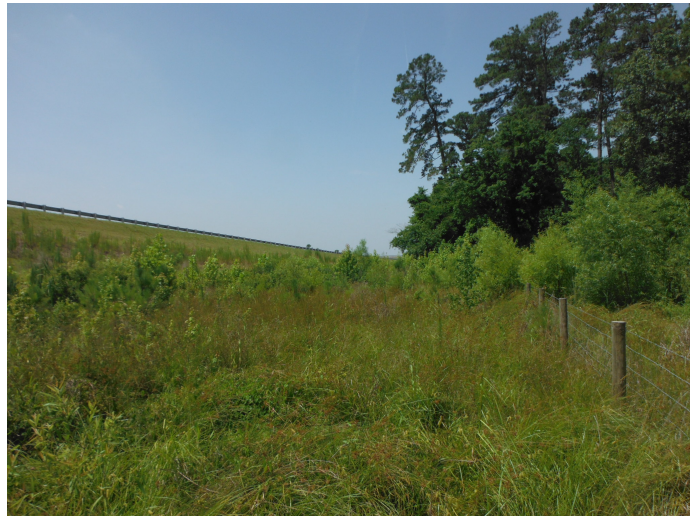
Photo Point #1 looking at Veg. Plot 2

There are a total of 2 vegetation monitoring plots established throughout the wetland restoration area. The 2014 vegetation monitoring of the site revealed an average tree density of 428 trees per acre. This average is well above the minimum success criteria of 320 trees per acre for Year 3. Vegetation Plot #2 is under the required 320 trees per acre for the 2014 monitoring period. The lower stem count is likely due to a disturbance in this area when the control of access fence was installed. NCDOT plans to perform a supplemental planting in the area surrounding this plot to increase the plant survival rate of the site.

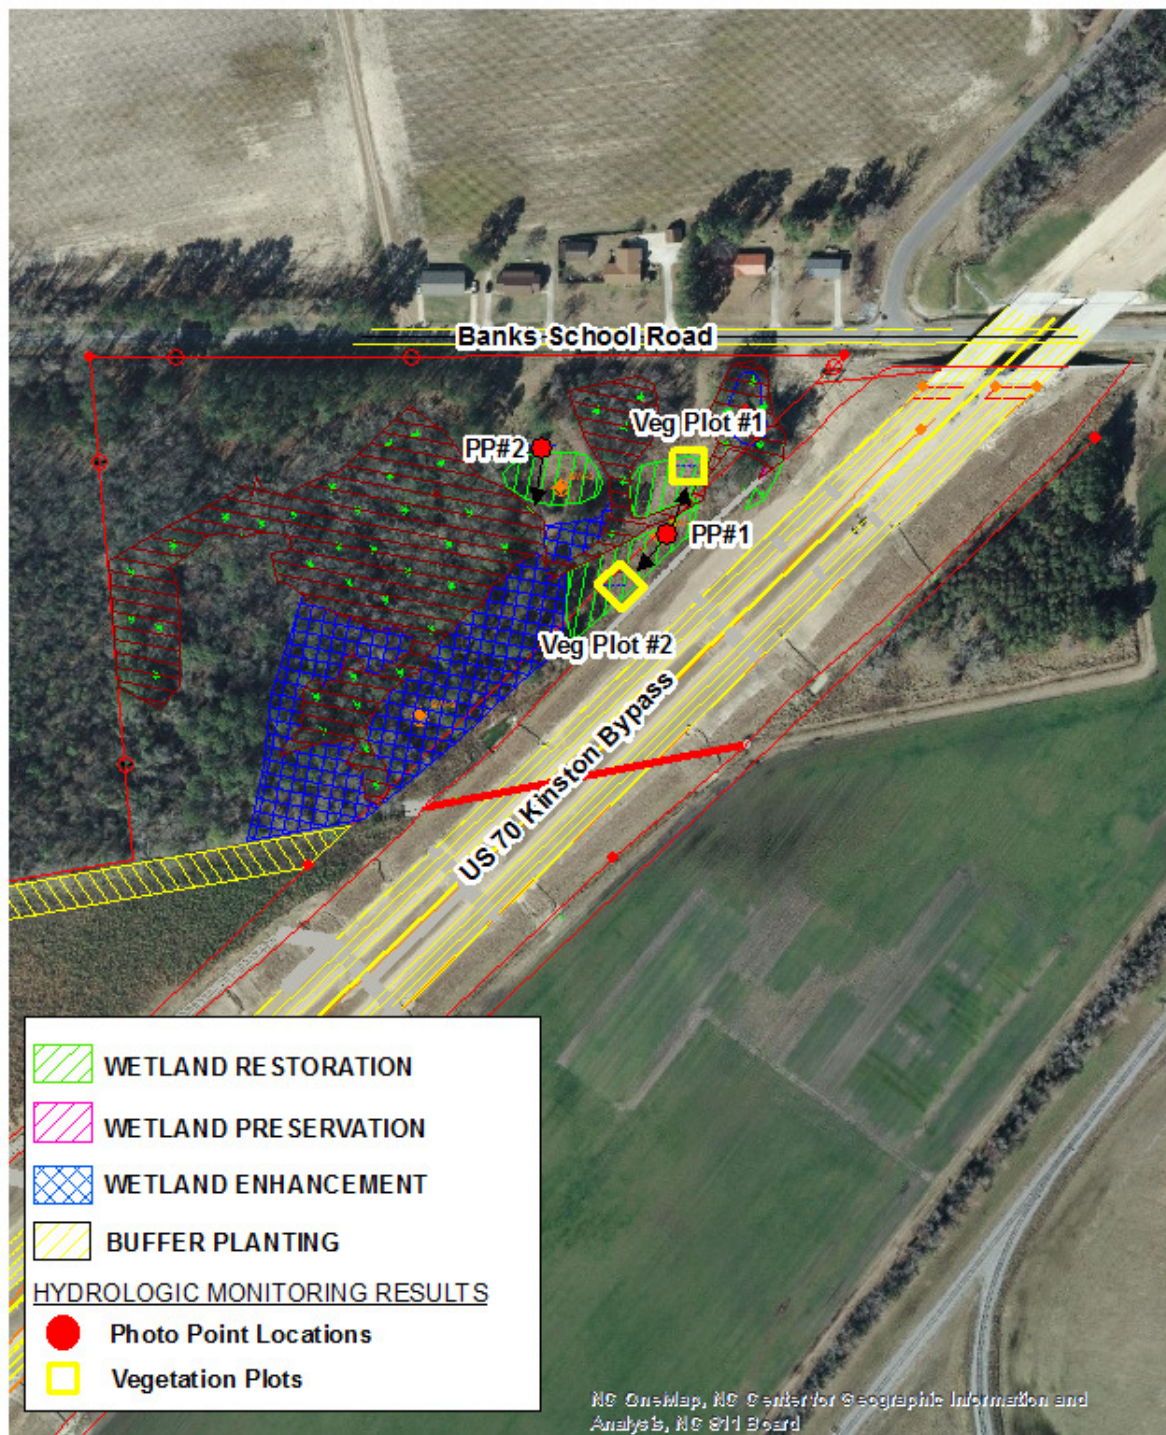
VEGETATION PLOT & PHOTO POINT LOCATIONS  
R-2719A Bank's School Road Mitigation Site  
Lenoir County, North Carolina

Location of Vegetation Plots  
and Gauges Are Shown
